Inspection Summary

Beach Home Inspections, Inc.
2309 South Stowe Road
Virginia Beach, VA 23457-1418
(757) 426-0900

Record 101 - Doe, John 1234 USA Road, Virginia Beach, VA 23456

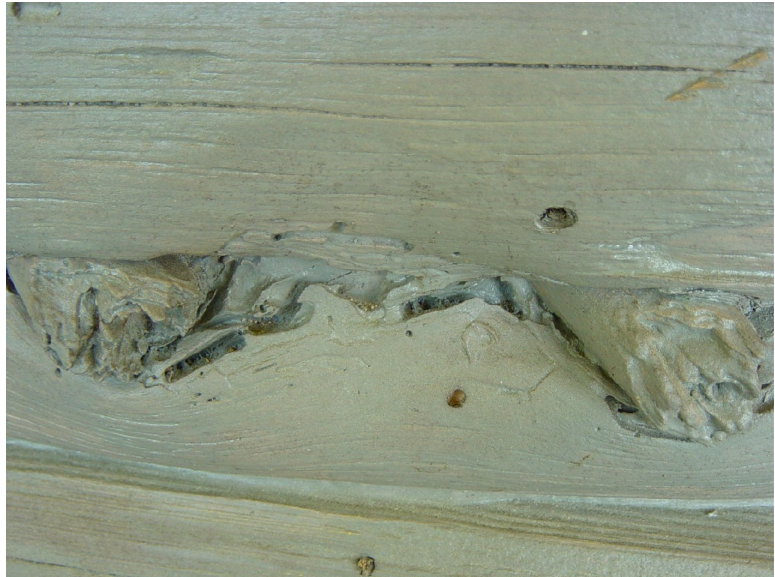
Other = "full" logs on the log cabin
There are signs of wood destroying insect activity in the logs, with multiple holes noted throughout and wood debris/dust on many of the flat surfaces and around window sills. All log wood products should be evaluated by a qualified contractor or termite control specialist and all needed repairs made.

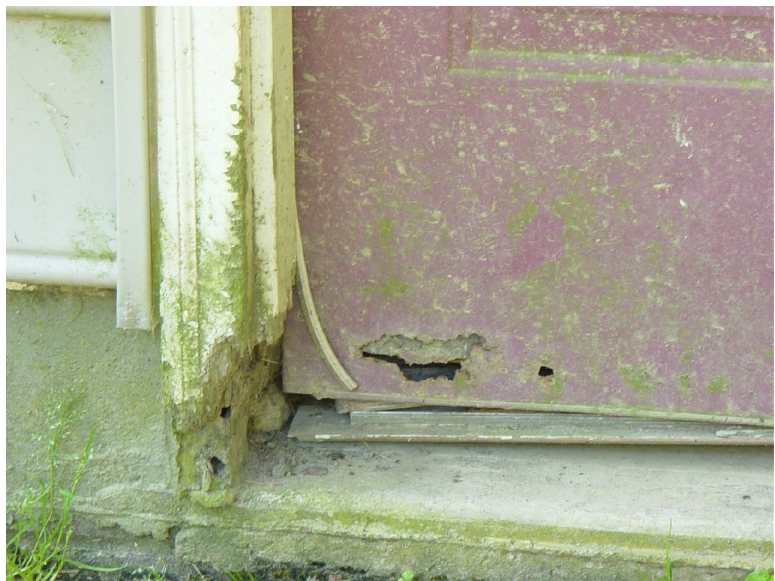
The log cabin has solid wood doors.
The addition has metal doors.
The rear garage entry door has severe moisture damage and rusting out at the base of the door and the door frame. This door slab and frame will need replacing to maintain a weather tight interior environment. Recommend evaluation/repair by a licensed exterior contractor.

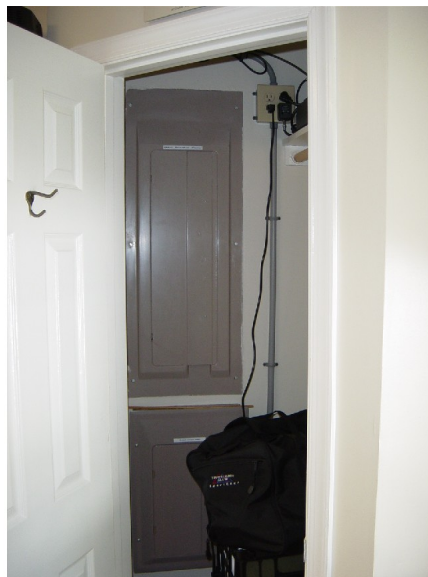
The main breaker panel and the added generator breaker panel are in a closet in the new addition office area. Breaker panels should be completely accessible and not in a closet space. Recommend evaluation/repair by a licensed electrical contractor.

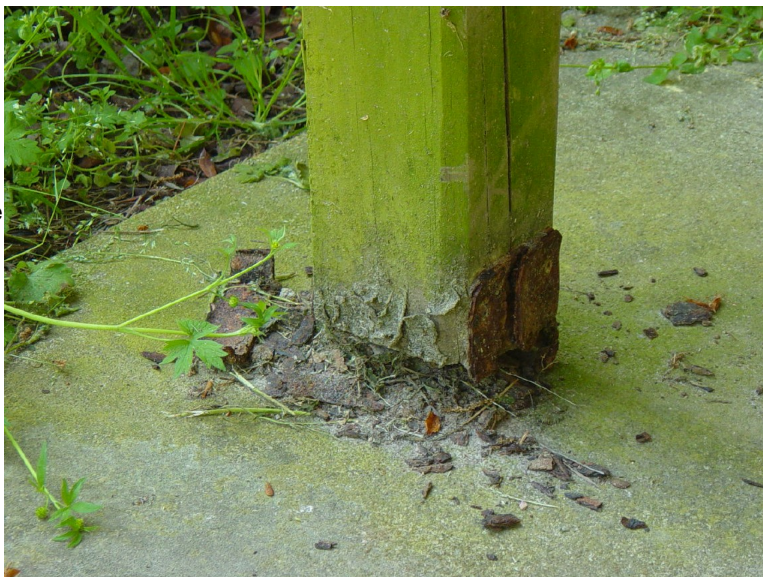
One of the support post for the rear master bedroom deck has extensive wood rot around the base and the metal securing bracket has completely rusted away. This issue is most likely related to the poor roof runoff drainage around the rear of the house which needs to be addressed. This support post and bracket needs repairing/replacing to prevent a possible support safety problem.

Recommend evaluation/repair by a licensed decking or exterior contractor.

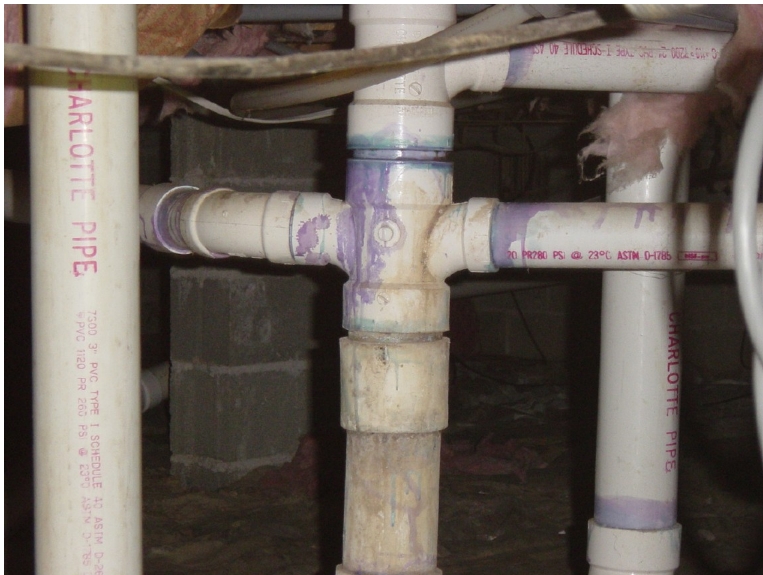
Evidence of past leaking around the rear bathroom toilet drain line in the crawl space but not leaking at the time of the inspection. - monitor
